Sun Valley Elkhorn Association
Sun Valley, ID

Report #: 38899-1
Beginning: November 1, 2024
Expires: October 31, 2025

RESERVE STUDY
Update "With-Site-Visit"

August 26, 2024

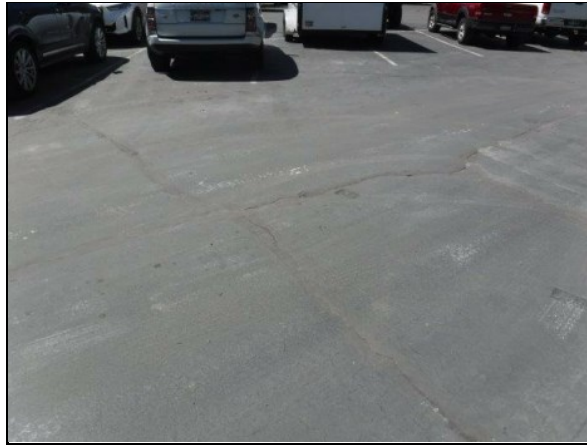
Useful Life:
40 years

Remaining Life:
2 years

Best Case: \$ 86,100

Worst Case: \$ 129,200

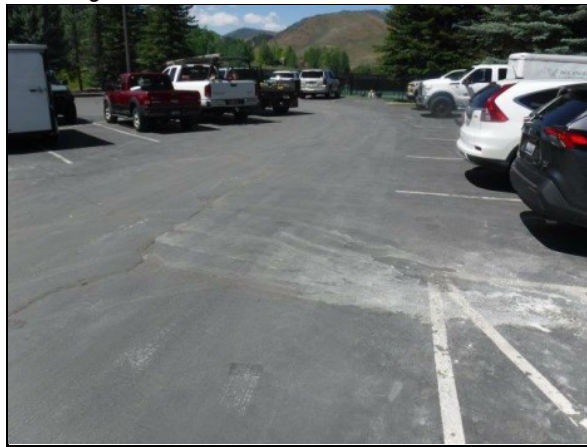
Useful Life:
5 years

Remaining Life:
0 years

Best Case: \$ 9,200

Worst Case: \$ 14,400

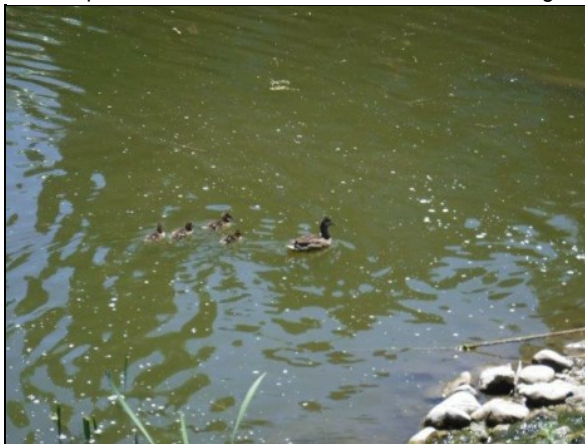
Useful Life:
10 years

Remaining Life:
1 years

Best Case: \$ 47,600

Worst Case: \$ 64,400

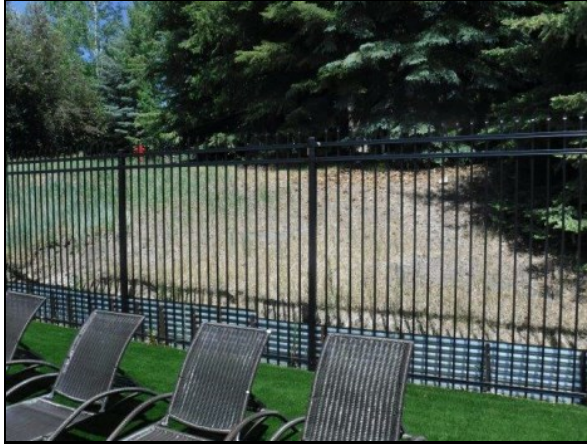
Useful Life:
40 years

Remaining Life:
37 years

Best Case: \$ 80,500

Worst Case: \$ 103,500

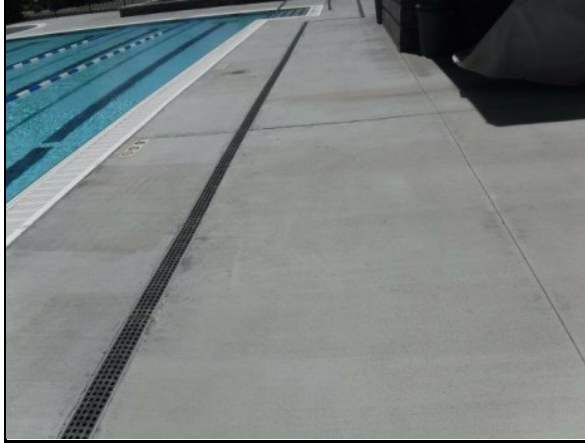
Useful Life:
40 years

Remaining Life:
37 years

Best Case: \$ 98,100

Worst Case: \$ 132,700

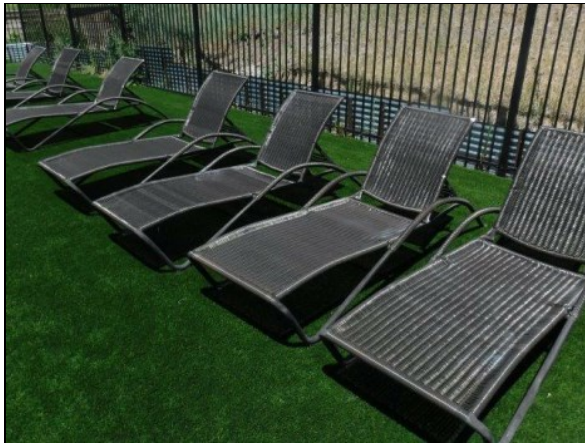
Useful Life:
8 years

Remaining Life:
2 years

Best Case: \$ 8,500

Worst Case: \$ 11,500

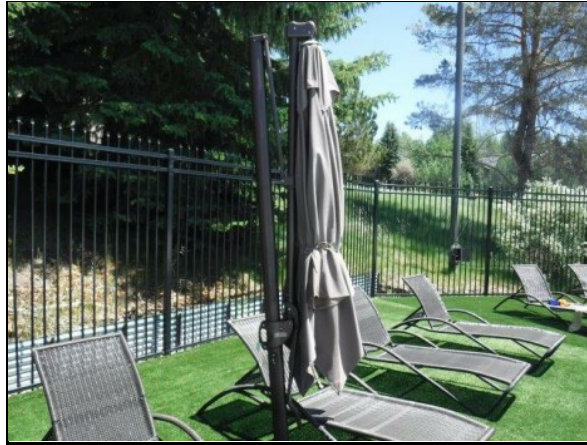
Useful Life:
4 years

Remaining Life:
2 years

Best Case: \$ 10,200

Worst Case: \$ 14,000

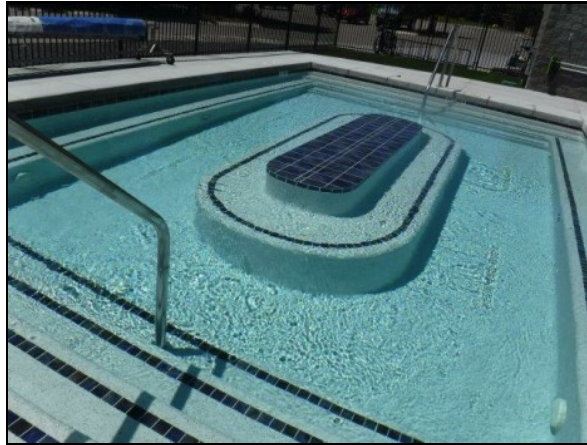
Useful Life:
15 years

Remaining Life:
12 years

Best Case: \$ 34,000

Worst Case: \$ 46,000

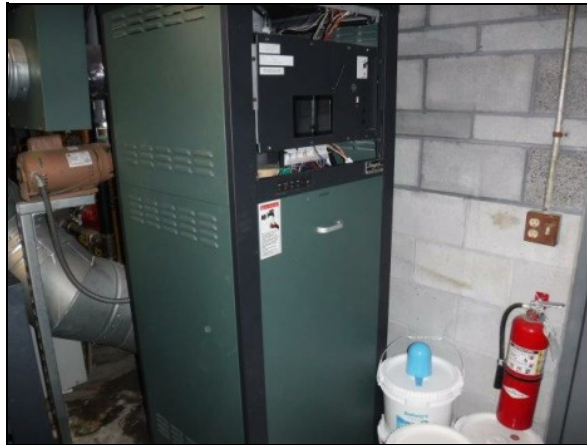
Useful Life:
12 years

Remaining Life:
9 years

Best Case: \$ 55,000

Worst Case: \$ 75,000

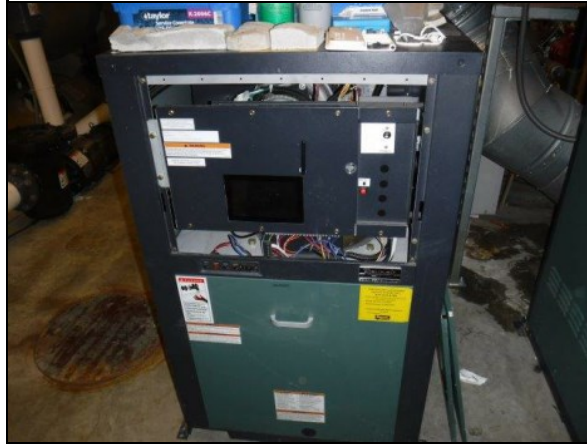
Useful Life:
12 years

Remaining Life:
9 years

Best Case: \$ 21,200

Worst Case: \$ 28,800

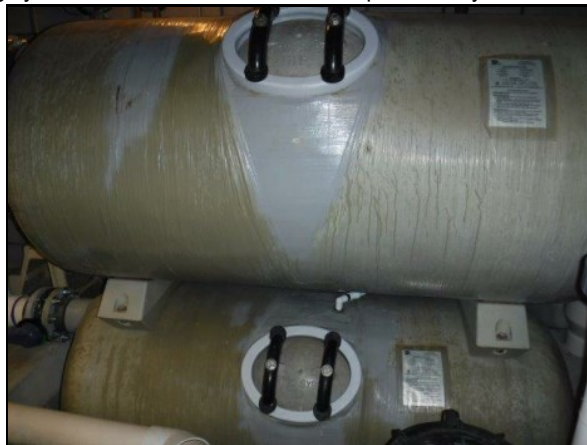
Useful Life:
40 years

Remaining Life:
27 years

Best Case: \$ 110,500

Worst Case: \$ 149,500

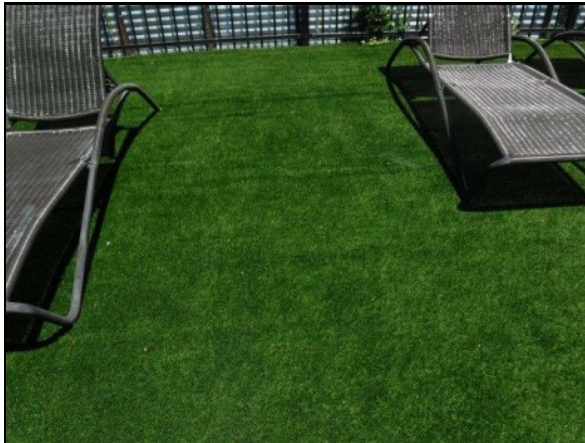
Useful Life:
20 years

Remaining Life:
17 years

Best Case: \$ 29,700

Worst Case: \$ 40,300

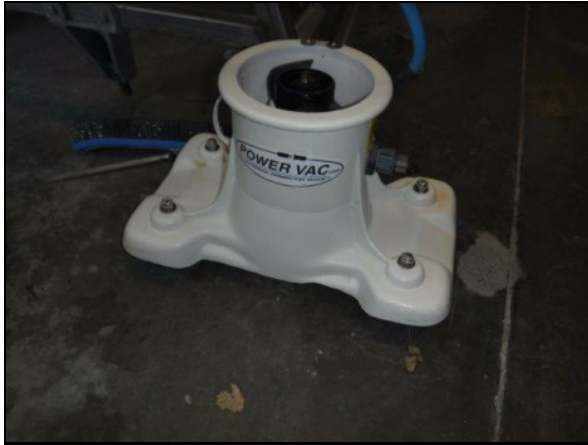
Useful Life:
5 years

Remaining Life:
1 years

Best Case: \$ 1,300

Worst Case: \$ 1,700

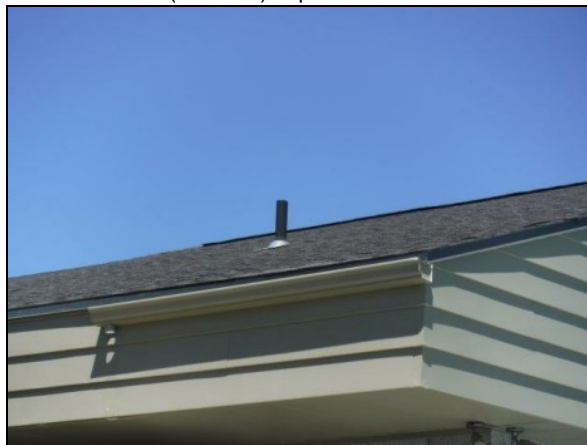
Useful Life:
30 years

Remaining Life:
5 years

Best Case: \$ 25,100

Worst Case: \$ 41,800

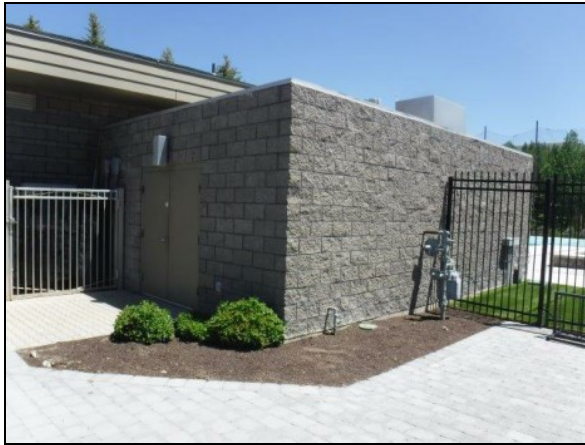
Useful Life:
30 years

Remaining Life:
5 years

Best Case: \$ 10,800

Worst Case: \$ 14,400

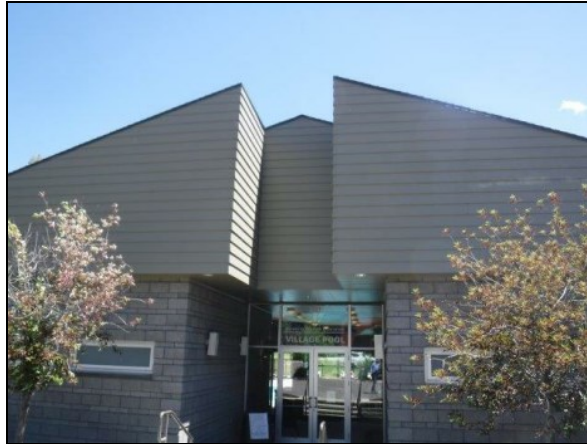
Comp #: 256 Village Pool Windows & Door - Replace

Comments: The windows are mostly horizontal sliders and fixed operation. Head flashing was not observed. The jambs and sills had sealant joints between the window frame and cladding. The weep holes at exterior lower corners were observed to be clear in the few windows sampled for our study. No observation of the critical underlying waterproofing details and flashing was part of our limited visual review. The underlying details and flashing are critical to maintaining the waterproofing of the building envelope and preventing structural damage as a result of water infiltration. A reserve study is a budget model, limited to visual exterior observation and research. It is outside the scope of our services, and the purpose of a reserve study, to assess the adequacy of the building envelope performance, as many of the key details are hidden from view. Periodic reviews by an architect, building envelope professional, etc. are prudent.

Many factors affect the useful life, including the quality of the window (design pressure rating), waterproofing and flashing details, building movement, and exposure to the elements, including wind driven rain. Those same variables, along with glazing and frame materials, can also greatly affect the appropriate choice and replacement costs. You can learn more about window design here: <http://rci-online.org/wp-content/uploads/2010-04-hinjosa.pdf>

Inspect regularly, including sealant, if any, and repair as needed. Typical sealant failures include a lack of adhesion to adjacent materials, tearing/splitting of the sealant itself, and loss of elastic ability. Loss of elastic ability can be caused by exposure to ultraviolet light, and general aging. Remove and replace all sealants as signs of failure begin to appear. Proper cleaning, prep work, and installation of specified joint design are critical for lasting performance. Keep weep holes free and clear to allow proper drainage of water that gets into the window frame. Do not block (caulk or seal) the gap at the top of head flashing, as this allows water that gets behind the siding to drain out.

We recommend the board conduct research well in advance of this project to help better define timing and costs (scope of work, material specifications, etc.). Further, we recommend that you hire a professional consultant (architect, engineer, building envelope consultant) to evaluate the existing windows, design and specify new installation requirements, assist with the bid process, and observe the construction to increase the likelihood of proper installation. We recommend all associations hire qualified consultants whenever they are considering having work performed on any high-risk building envelope components (roof, walls, windows, decks, exterior painting and caulking/sealant).

Note: Costs below factor for professional architectural details, specifications, and installation oversight. Any needed repair of the underlying structural framing can add significantly to the project cost. No observation of the critical underlying waterproofing details and flashing was part of our limited visual review.

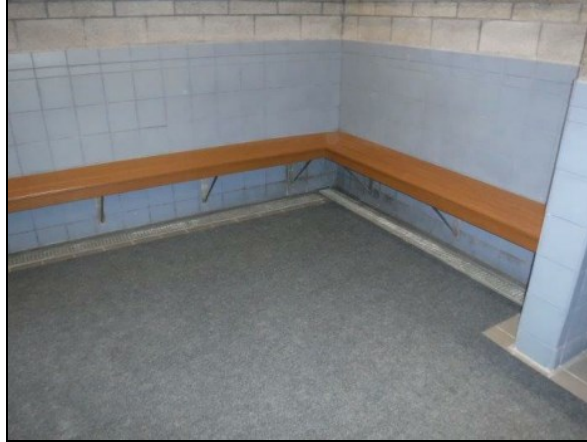
Comp #: 267 Village Pool House Sauna-Repair/Replace

History: Heater replaced 2016 ~\$1,500.

Repair as needed with operating funds. Clean the sauna periodically. Light sanding can refresh the appearance of the cedar interior. Inspect the heater regularly and test for performance. Repair the heater promptly to ensure safety. The heater element replacement costs should be less than \$1,000. If a large-scale repair becomes known, funding can be added to a future reserve study.

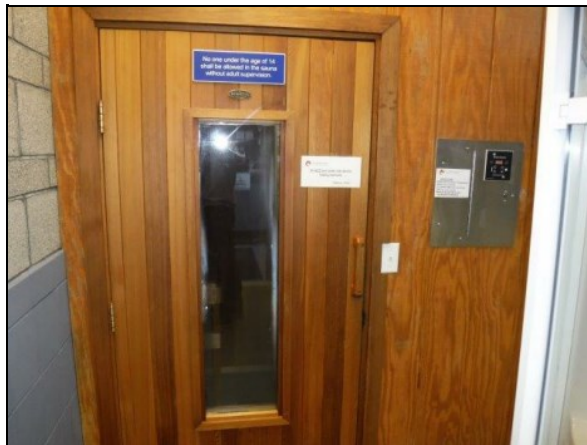
Comp #: 268 Village Pool House Steam Room - Replace

History: Replaced 2021 ~\$32,300.

Clean and inspect regularly, and repair promptly.

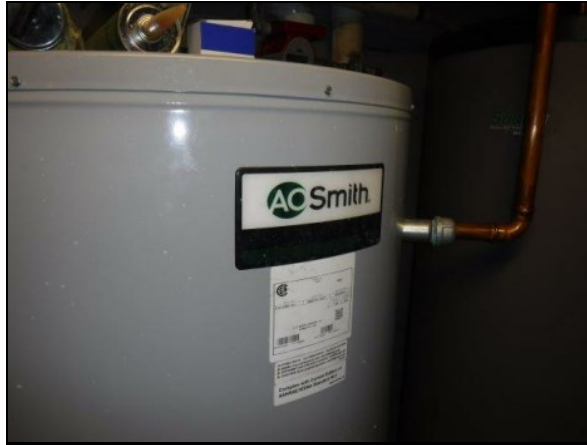
Comp #: 273 Village Pool H2O Storage Tanks - Replace

History: 1 tank replaced 2020 ~\$3,100.

Due to the differing ages of the tanks, there is no predictable basis for reserves funding. Plan to replace each tank, as needed, utilizing operating funds.

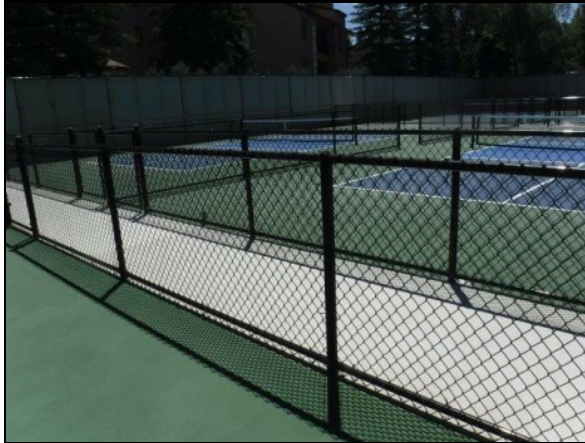
Comp #: 320 Village Pickle & Tennis Fence - Replace**Quantity: Chain link**

History: Replaced 2020.

Comments: The chain link fencing appeared to be stable with no damages observed.

With ordinary care and maintenance, and if not damaged or abused, anticipate the service life in the range of the court surface before replacement is needed.

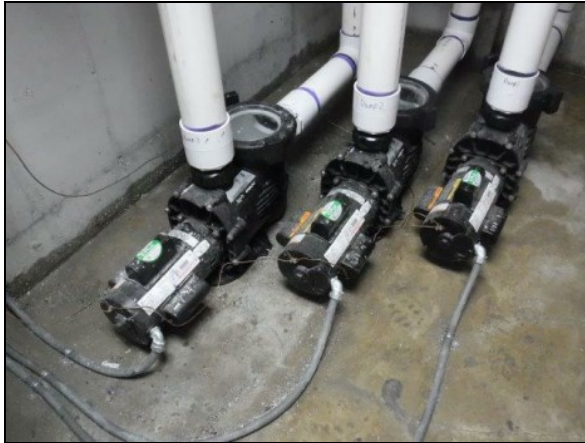
Comp #: 414 Harker Pool Pumps - Repair/Replace

Comments: This component represents repair/replacement the Harker pool pumps.

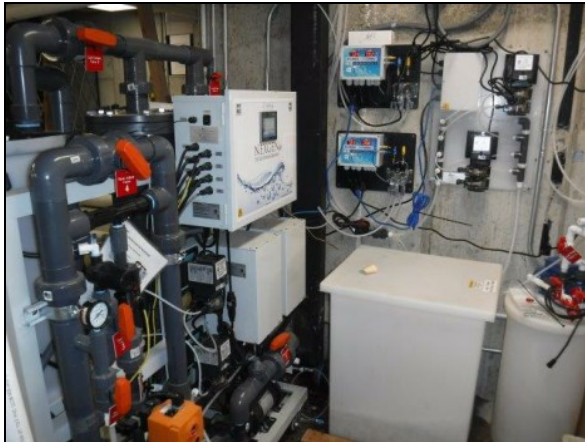
Comp #: 415 Harker Pool Salt System-Repair/Replace

Comments: This component represents repair/replacement the Harker pool saltwater system.

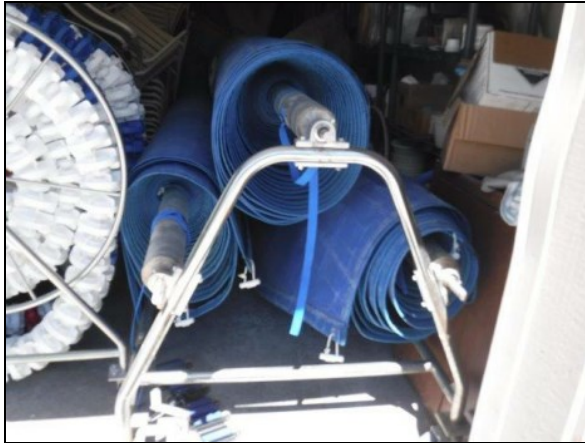
Comp #: 416 Harker Pool Cover - Repair/Replace

Comments: This component represents repair/replacement the Harker pool cover.

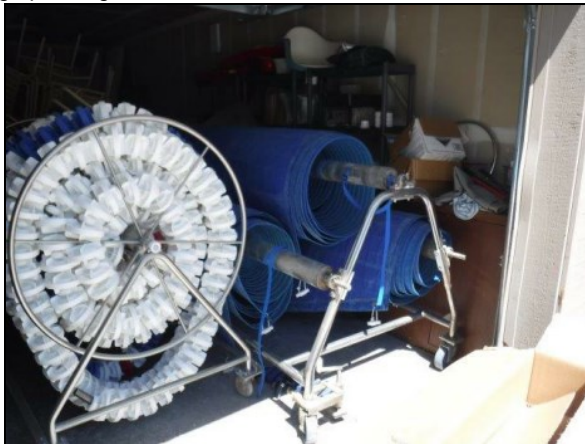
Comp #: 417 Harker Spa Cover - Repair/Replace

Comments: This component represents repair/replacement the Harker spa cover.

Plan to replace the cover utilizing operating funds.

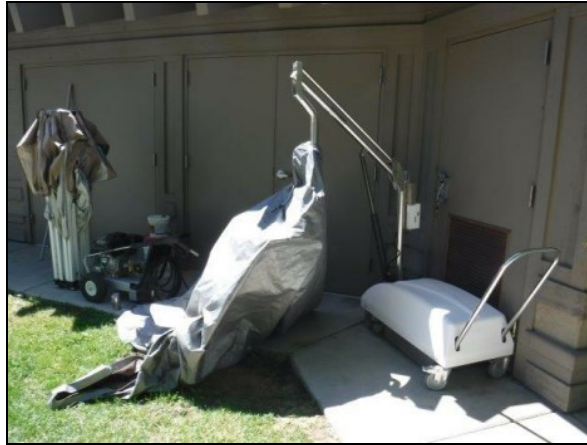
Comp #: 418 Harker Pool ADA Lift - Repair/Replace

History: Replaced 2015 ~\$6,900.

Comments: This component represents repair/replacement the Harker pool ADA lift.

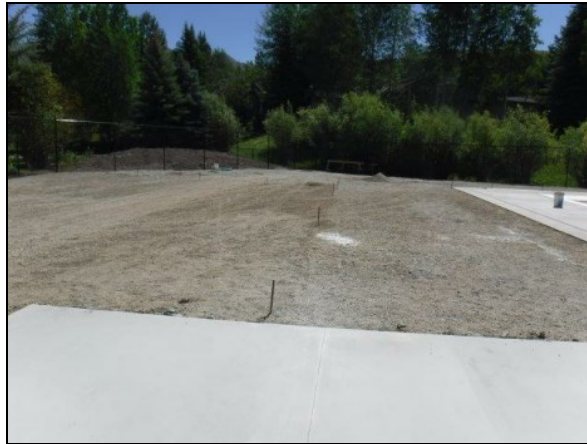
Comp #: 420 Harker Pool Artificial Turf - Replace

Comments: This component represents repair/replacement of the Harker pool artificial turf.

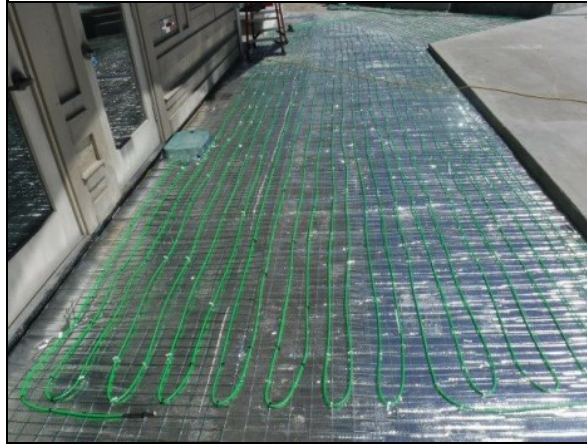
Comp #: 421 Harker Pool Radiant Heating - Replace

Comments: This component represents repair/replacement of the Harker pool radiant heat system.

The useful life of the system is dependent upon its actual use, thus we are unable to estimate its remaining useful life. If replacement becomes necessary, and costs warrant it, funding can be added to this component in a future reserve study.

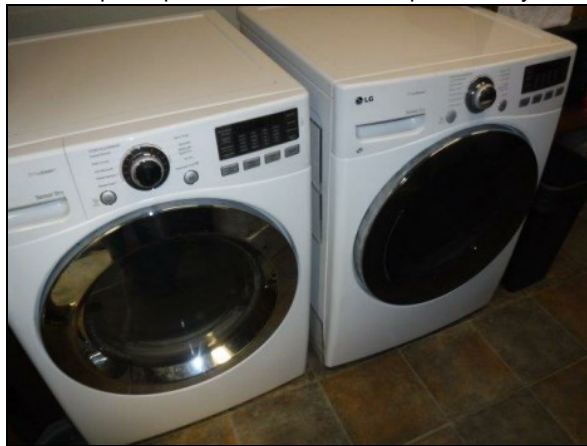
Comp #: 422 Harker Pool Laundry Machines - Replace

Comments: This component represents repair/replacement of the Harker pool laundry machines.

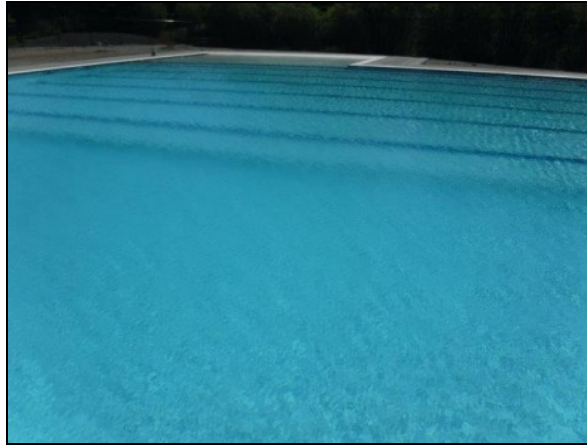
Comments: Components #400 thru 421 represent future replacement cycles for individual components. This component factors for a complete renovation of the pool and spa area similar to what occurred in 2024 (redesign of the pool, deck replacement, equipment replacement, etc). Cost allowances here exclude the costs in components #400 thru 421.

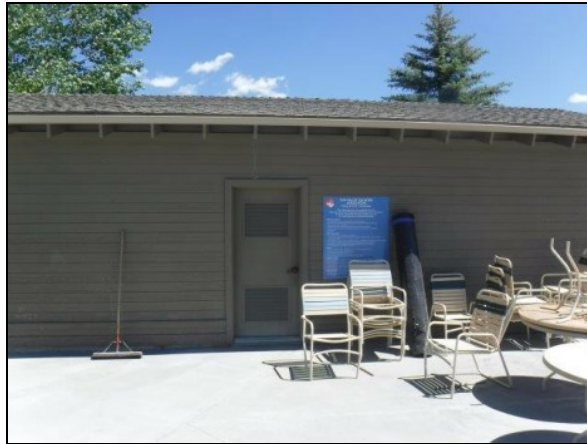
Comp #: 446 Harker Pool Storage Roof - Replace

Comments: This component represents repair/replacement of the Harker pool storage building roof.

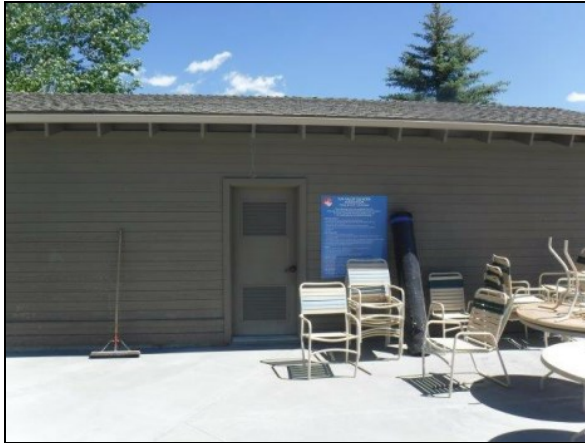
Comp #: 447 Harker Pool Storage Siding - Replace

Comments: This component represents repair/replacement of the Harker pool storage building siding.

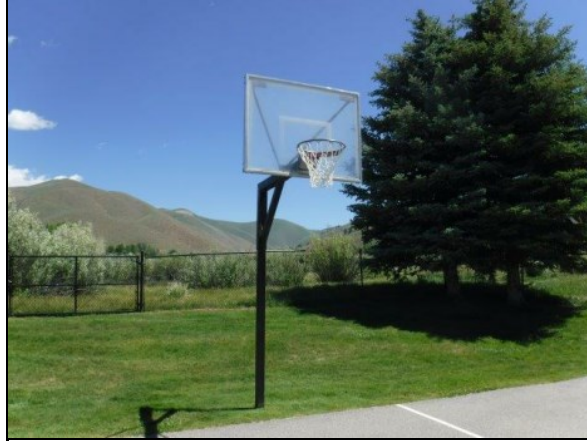
Comments: The component represents repair/replacement of the Harker Park fence.

Useful Life:
40 yearsRemaining Life:
39 years

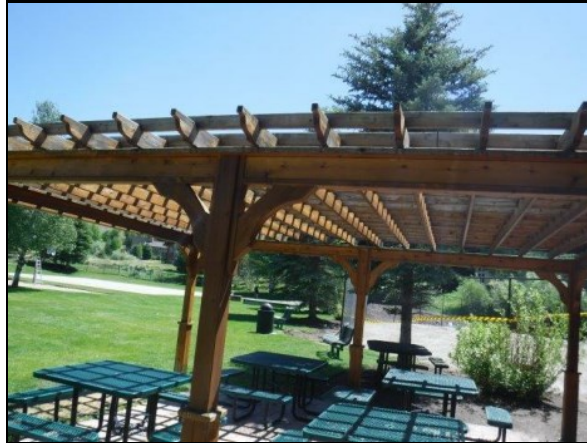
Comments: This component represents repair/replacement of the Harker Park trellis.

Useful Life:
20 yearsRemaining Life:
10 years

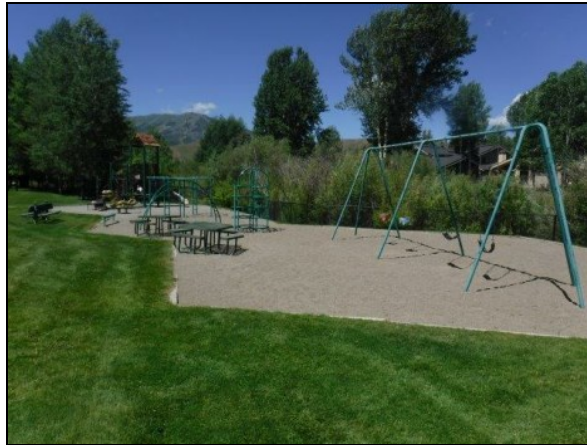
Comp #: 510 Harker Park Play Equipment - Replace

History: Replaced 2015 ~\$25,300.

Replacement cycles vary depending on the amount of use/abuse, however, expect to complete an extensive park area renovation at roughly the time frame listed below. Inspect for stability, damage and excessive wear, and utilize operating funds for any repairs needed between replacement cycles.

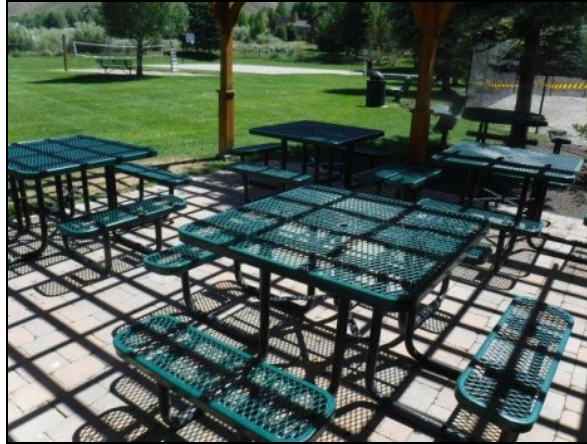
Comp #: 515 Harker Park Furniture - Repair/Replace

History: Replacements 2015 ~\$5,600.

Comments: The park furniture appeared to be functional. No damages were observed.

Inspect regularly, and repair as needed with operating funds. Clean with an appropriate cleaner (refinish if desired) using operating funds. Plan to replace pieces individually, as needed, with operating funds. If a large scale replacement project becomes necessary or desired, funding can be added to this component in a future study.

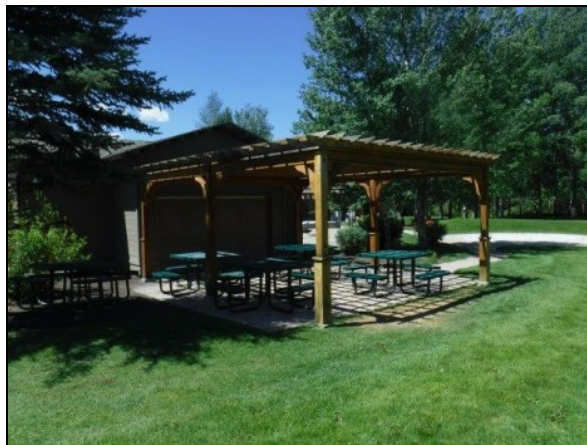
Comp #: 520 Harker Park BBQ Station - Repair/Replace

Comments: This component represents repair/replacement of the Harker Park barbeque.

The estimated costs to replace the barbeque are below the minimal threshold for reserves funding. Plan to replace the unit with operating funds.

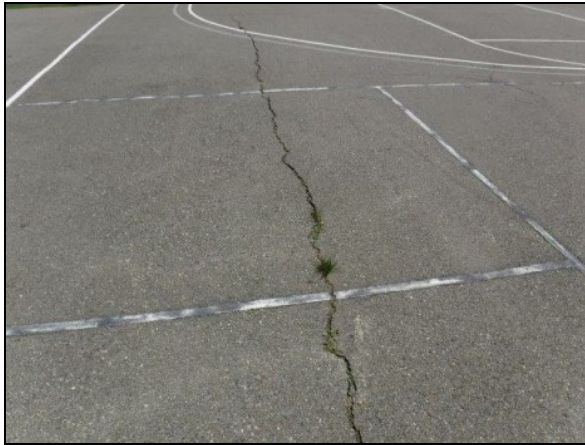
Comments: The sports court was noted to have cracks, however, it appeared to still be functional.

In addition to periodic seal/repair projects (see component #526), plan for an eventual total resurface of the court. Repair the base as needed at that time to ensure positive drainage. As routine maintenance, inspect regularly, clean as needed, and fill cracks with operating funds. See component #324 for cyclical seal coating and striping.

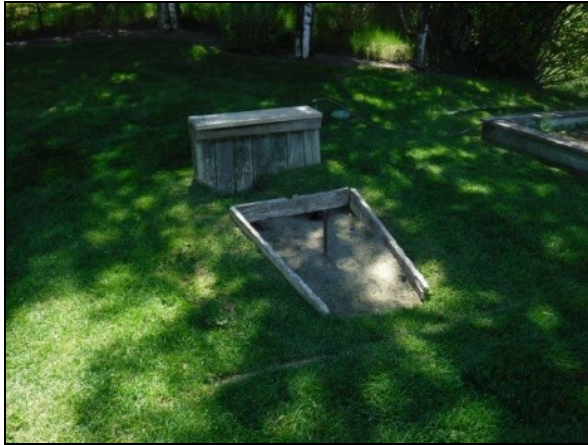
Comp #: 537 Harker Park Horseshoes - Repair/Replace

Comments: This component represents repair/replacement of the horseshoes game set.

Plan to replace the set, as needed, with operating funds.

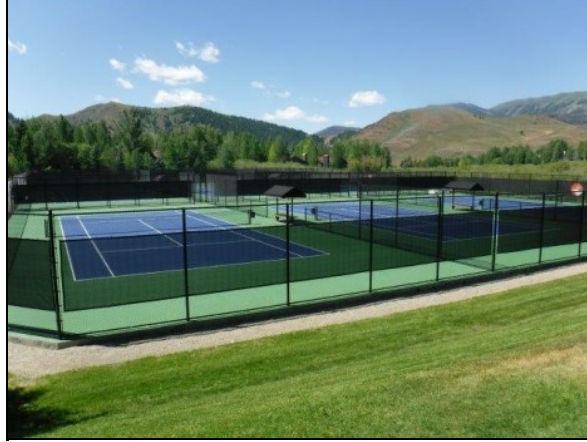
Comments: This component represents repair/replacement of the Harker tennis court fence.

Useful Life:
40 yearsRemaining Life:
37 years

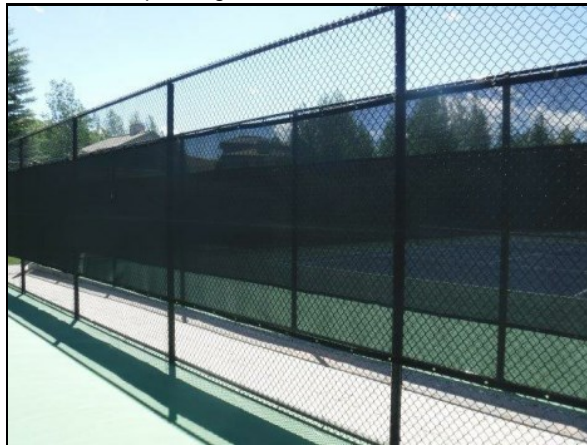
Useful Life:
10 yearsRemaining Life:
2 years

Plan to replace the screens, as needed, with operating funds.

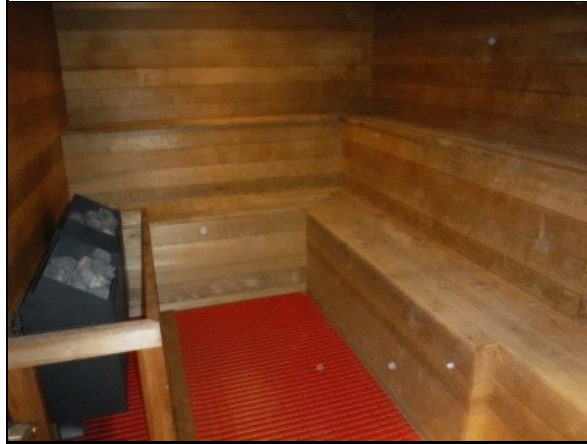
Comp #: 831 Harker Center Sauna - Repair/Replace

Comments: No damages to the sauna were observed or reported.

Repair as needed with operating funds. Clean the sauna periodically. Light sanding can refresh the appearance of the cedar interior. Inspect the heater regularly and test for performance. Repair the heater promptly to ensure safety.

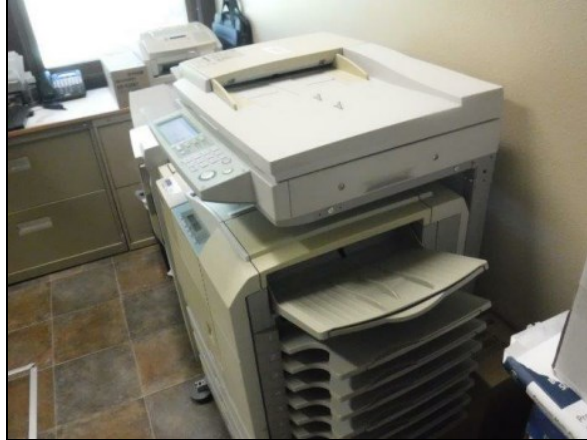
Comp #: 843 Harker Center Copy Machines - Replace

Comments: Two copy machines were present at the time of our site visit, a black and white unit and a color unit. The community's manager reported in a prior reserve study the black and white unit will not be replaced when it fails. Funding below is for the color unit only.

Plan to replace the unit at roughly the time frame below to maintain function. The costs can vary widely based on brands and functionality, therefore a mid-range funding allowance has been incorporated here.
