## "Full" Reserve Study

### **Sun Valley Elkhorn Association Sun Valley, ID**

**Report #: 38899-0**  
**For Period Beginning: November 1, 2020**  
**Expires: October 31, 2021**

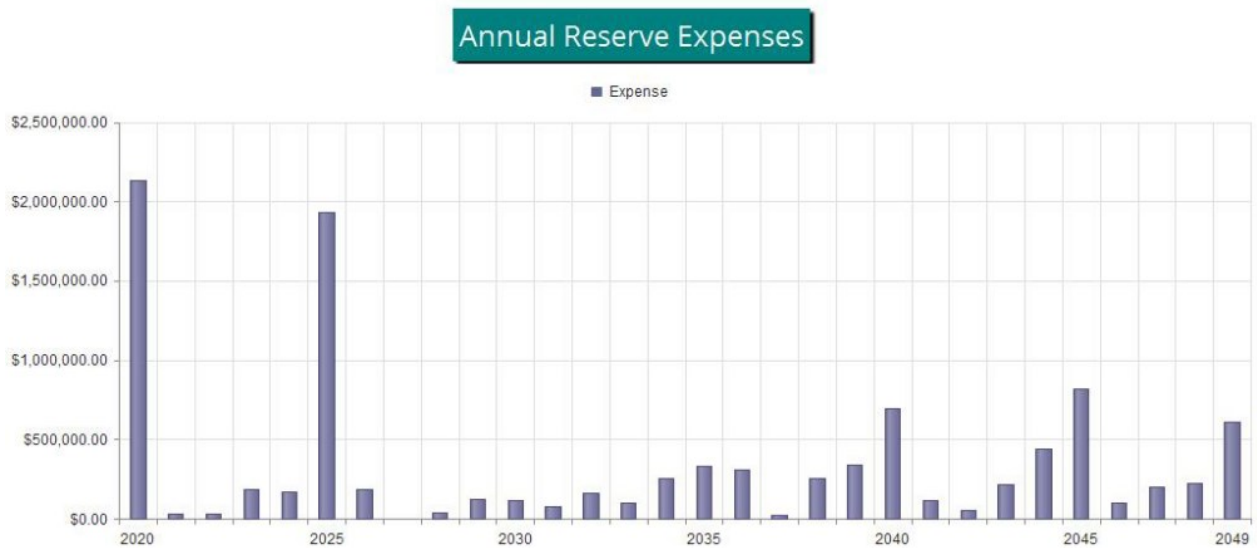
Figure 1

The figure below summarizes the projected future expenses at your association as defined by your Reserve Component List. A summary of these expenses are shown in the 30-yr Summary Table, while details of the projects that make up these expenses are shown in the Cash Flow Detail Table.

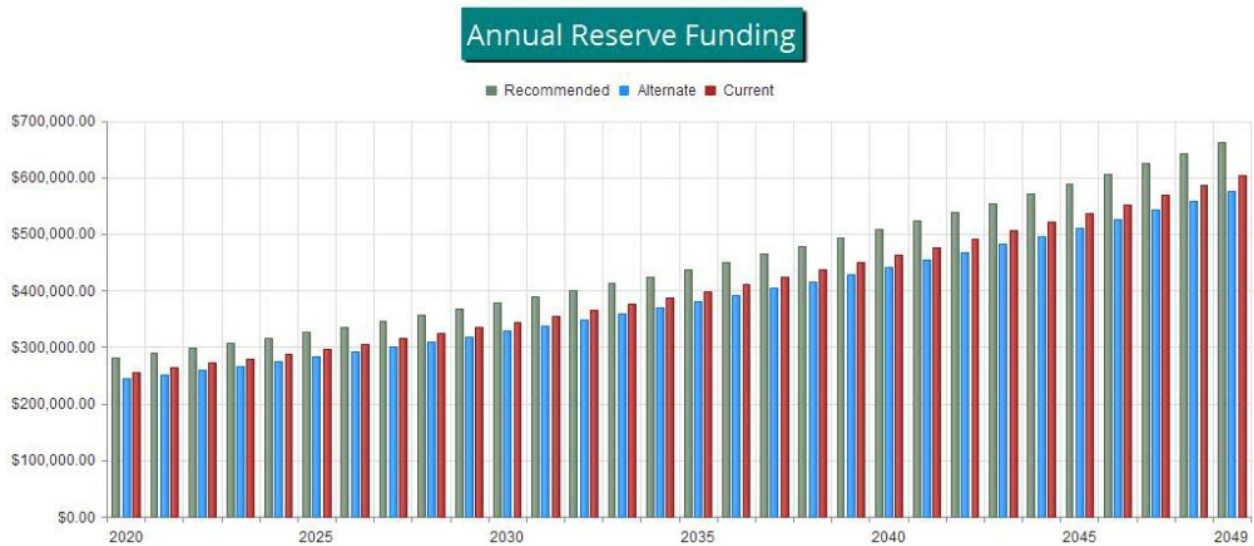
Figure 2

Based on your current Percent Funded and your near-term and long-term Reserve needs, we are recommending budgeted contributions of \$23,425 per month this Fiscal Year. The overall 30-yr plan, in perspective, is shown below. This same information is shown numerically in both the 30-yr Summary Table and the Cash Flow Detail Table.

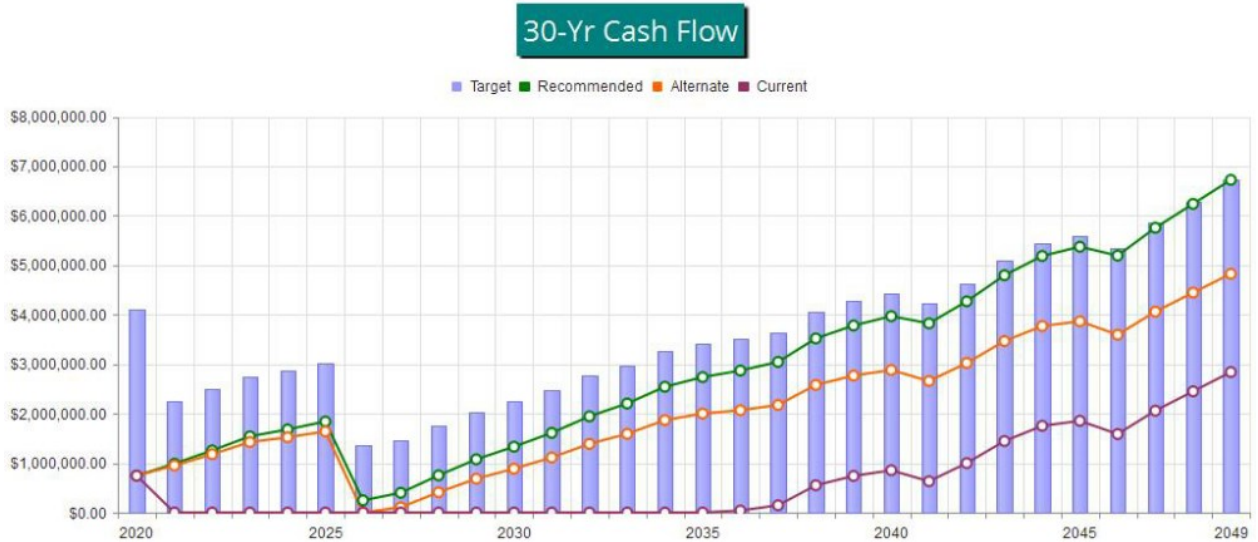
Figure 3

The following chart shows your Reserve balance under our recommended Full Funding Plan, an alternate Baseline Funding Plan, and at your current budgeted contribution rate (assumes future increases), compared to your always-changing Fully Funded Balance target.

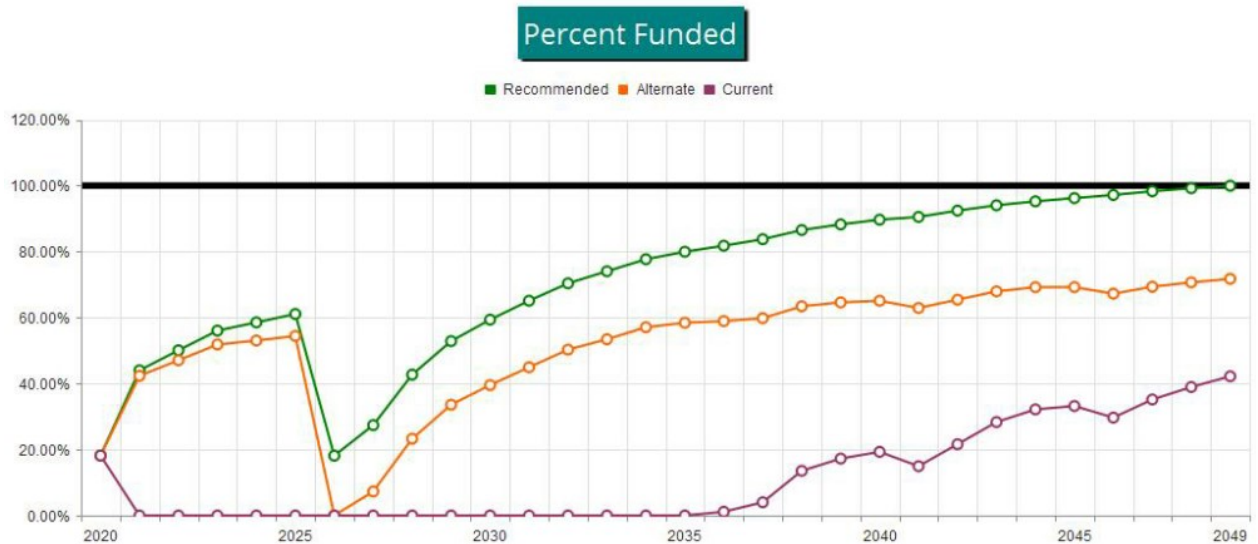
Figure 4

This figure shows the same information plotted on a Percent Funded scale. It is clear here to see how your Reserve Fund strength approaches the 100% Funded level under our recommended multi-yr Funding Plan.

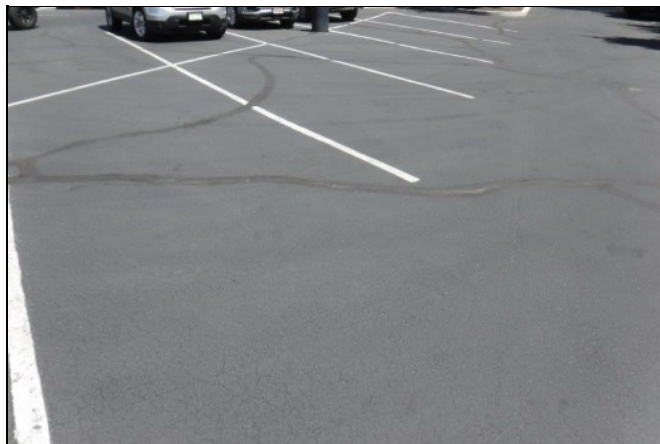
Useful Life:  
30 years

Remaining Life:  
5 years

Best Case: \$ 57,400

Worst Case: \$ 71,800

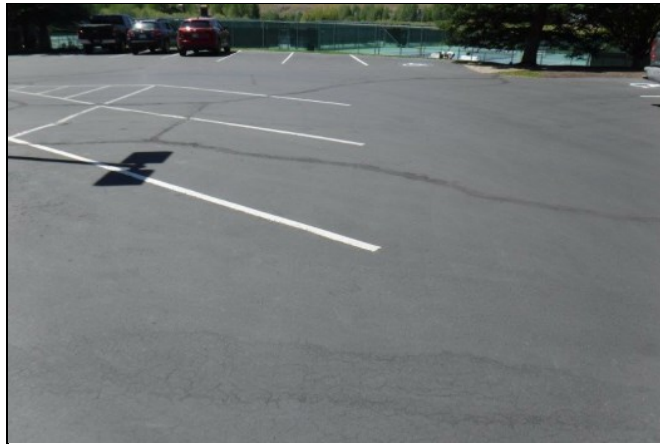
Useful Life:  
3 years

Remaining Life:  
0 years

Best Case: \$ 6,800

Worst Case: \$ 8,800

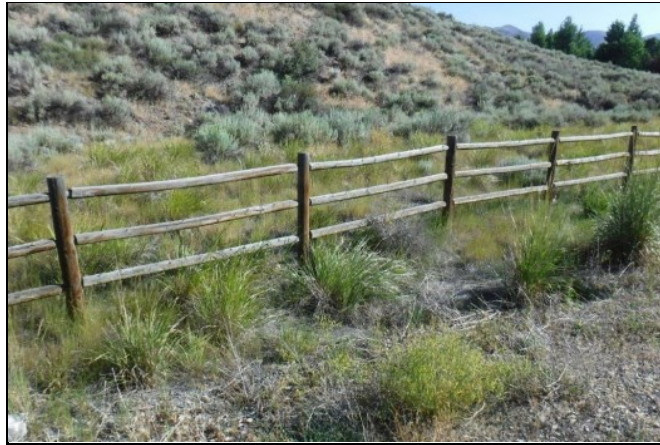
Useful Life:  
20 years

Remaining Life:  
5 years

Best Case: \$ 135,000

Worst Case: \$ 162,000

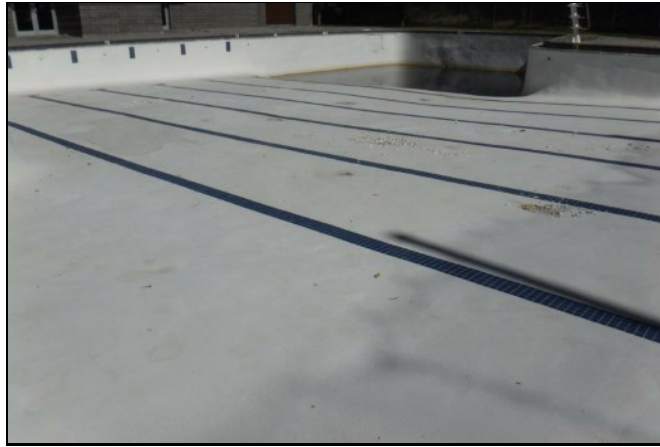
Useful Life:  
20 years

Remaining Life:  
0 years

Best Case: \$ 190,000

Worst Case: \$ 210,000

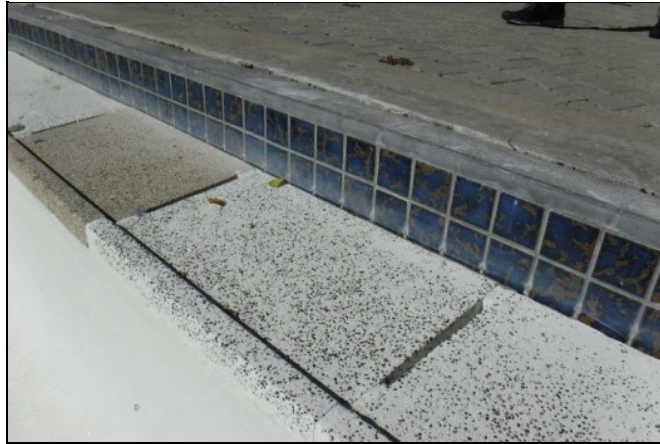
Useful Life:  
20 years

Remaining Life:  
0 years

Best Case: \$ 9,300

Worst Case: \$ 13,000

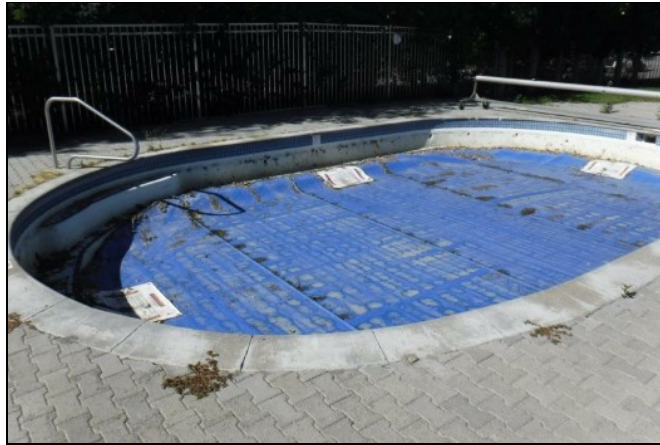
Useful Life:  
15 years

Remaining Life:  
0 years

Best Case: \$ 15,000

Worst Case: \$ 20,000

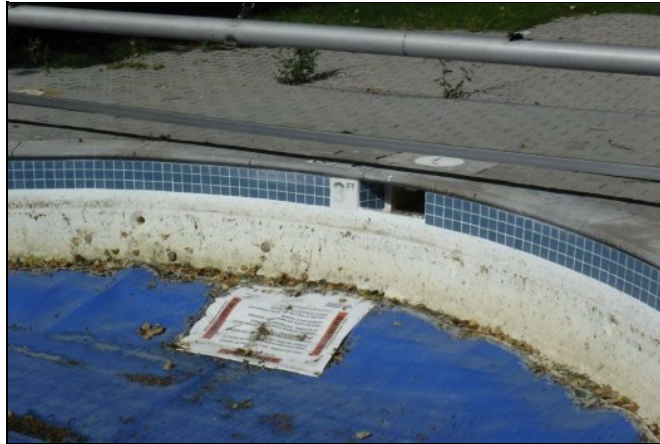
Useful Life:  
15 years

Remaining Life:  
0 years

Best Case: \$ 2,000

Worst Case: \$ 2,800

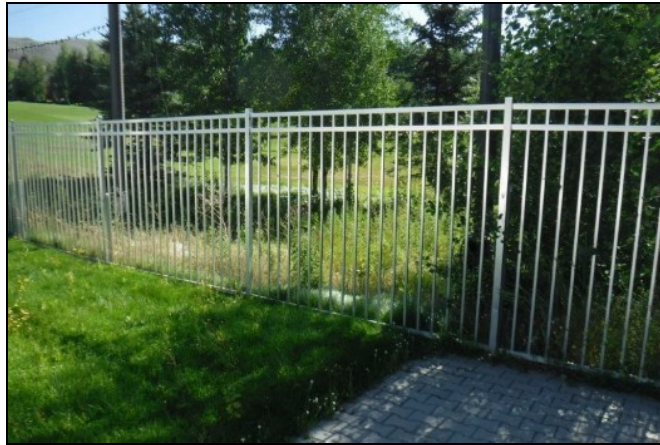
Useful Life:  
40 years

Remaining Life:  
0 years

Best Case: \$ 39,000

Worst Case: \$ 43,000

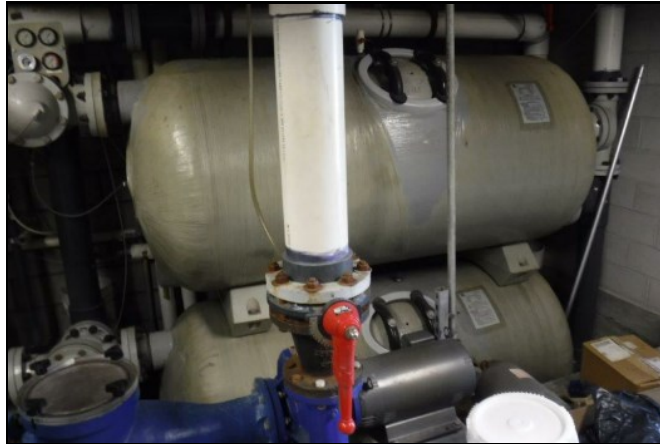
Useful Life:  
40 years

Remaining Life:  
30 years

Best Case: \$ 95,000

Worst Case: \$ 105,000

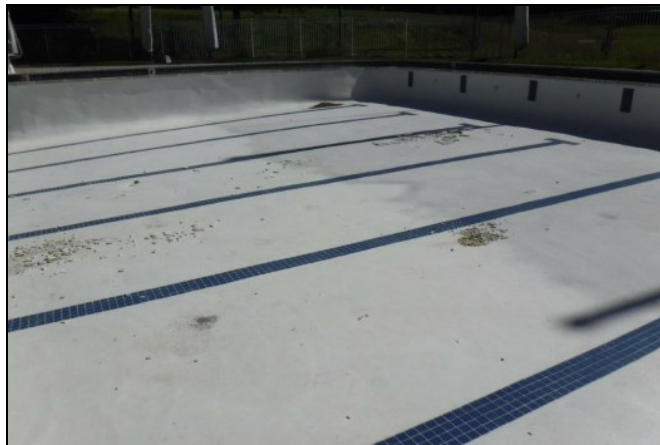
Useful Life:  
40 years

Remaining Life:  
0 years

Best Case: \$ 1,025,000

Worst Case: \$ 1,075,000

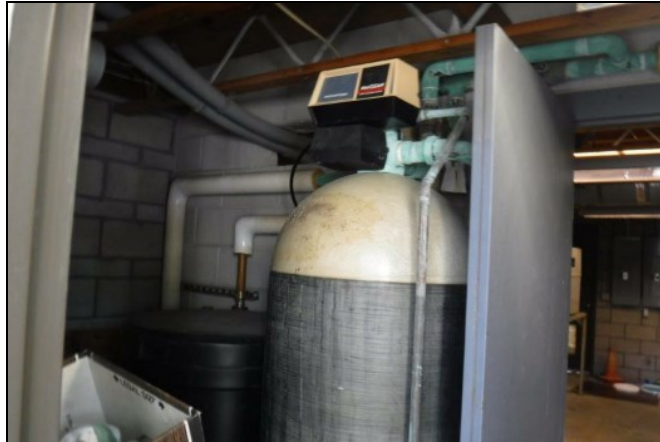
**Comp #: 242 Water Softener - Replace**

Comments: Clubhouse features MacClean water softener system. No problems reported at the time of our site visit. We presume that system will be replaced at the time of the 2021 pool renovation project as pump room will reportedly be reworked at this time.

Water softener systems can vary in price depending on a number of factors, including salt storage capacity. Funding allowances assume replacement with similar sized system.

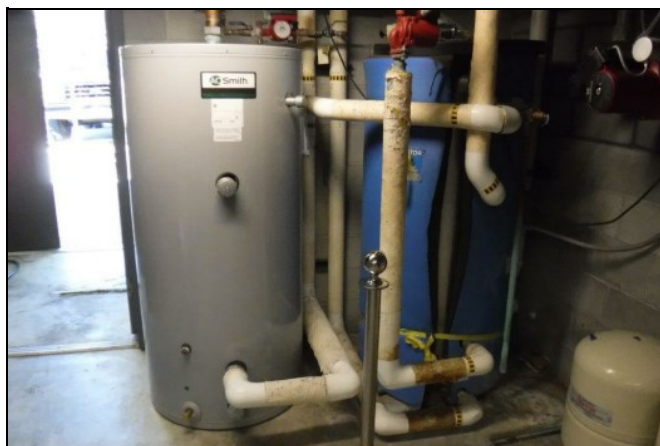
**Comp #: 243 Water Storage Tanks - Replace**

Comments: Association records reflected that one water storage tank was replaced in 2020 at a cost of \$3,117.68.

Due to the differing ages of tanks, there is no predictable basis for expenses affecting reserves as individually tanks are too small in cost to qualify for reserve funding. Replace as needed utilizing general maintenance reserve funds.

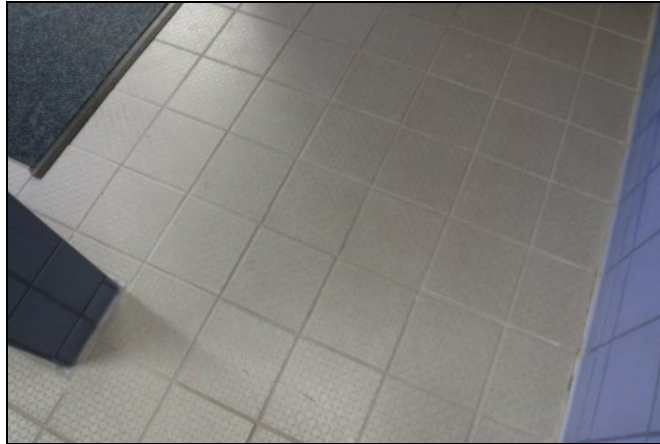
**Comp #: 255 Clubhouse Flooring - Replace**

Comments: Village pool clubhouse features tile flooring. Tile appeared generally intact, with no major damage or deterioration. Our source reported that tile within locker room showers was replaced around 2018.

With ordinary care and maintenance, tile can last for an extended period of time. However, tile may eventually need to be replaced due to grouting issues or appearance considerations.

As part of ongoing maintenance, inspect periodically, replace any damaged tiles, clean, repair, and seal grout using general maintenance funds.

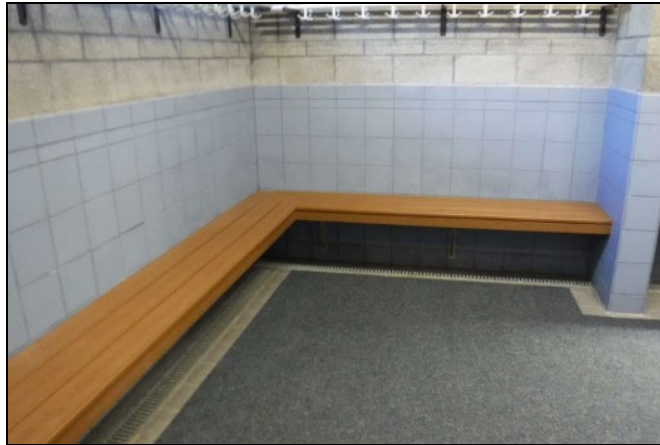
Comments: Village pool clubhouse locker rooms featured basic fixtures within shower stalls, toilet area and changing room. Fixtures and finishes are assumed to be primarily original to ~ 1999 construction, however our source reported that tile within showers was replaced around 2018.

Clean and maintain as needed to extend useful life. Simple, durable materials typically have an extended useful life, however, many communities choose to refurbish the locker rooms periodically for aesthetic updating, and/or function. Doing so may include tile work (including removal or replacement of tile on walls), sinks, toilets and other plumbing fixtures, counter tops, lighting, ventilation, stall dividers, benches, lockers, etc. Cost can vary widely based on scope and quality of materials chosen; a mid range funding allowance is factored below.

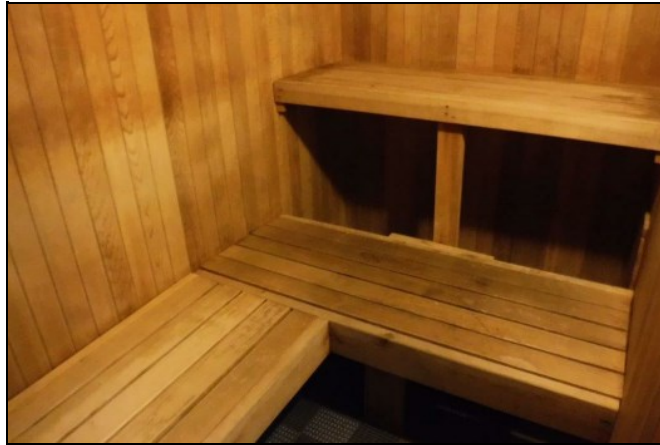
**Comp #: 270 Sauna - Repair/Replace**

Comments: Generally, the cedar wood interior of the sauna appeared to be in intact condition.

Repair as needed using general maintenance funds. Clean saunas periodically as needed. Light sanding can refresh the appearance of cedar interior. Inspect the heater regularly and test for performance, repair promptly to ensure safety. Heater element replacement cost should be less than \$1,000. If larger-scale repair becomes known, funding can be added to a future reserve study.

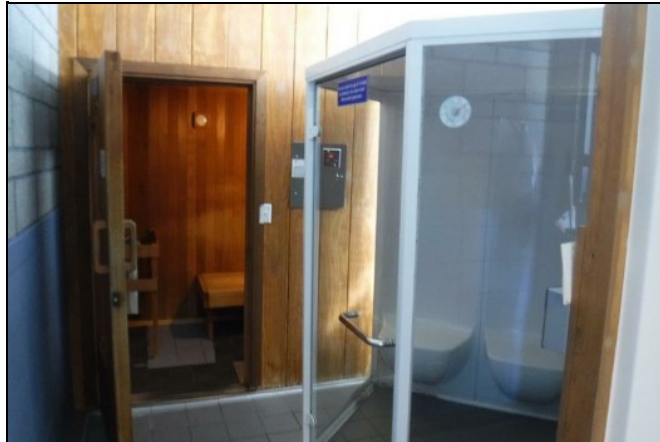
**Comp #: 275 Steam Room - Repair/Replace**

Comments: Our source reported plans to replace existing steam room in 2020/2021 with an Am-Finn model. Cost was projected at \$32,265 for the steam room unit and an additional \$10k in flooring, electrical and plumbing work for a total project cost of approximately \$32,265.

This component factors periodic replacement of steam room based on estimate provided by client. Cost can vary widely based on unit chosen.

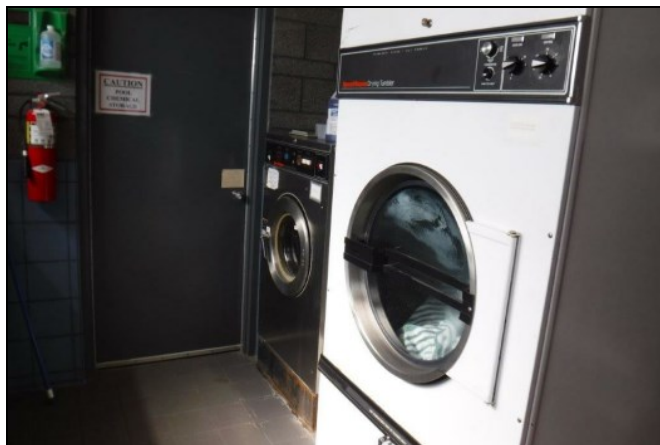
**Comp #: 280 Commercial Laundry Machines-Replace**

Comments: Laundry machines within Village pool clubhouse are dated SpeedQueen models. Our source reported that units are due for replacement, however the association has been able to keep units operational through periodic repairs.

This component factors periodic replacement of equipment to maintain function.

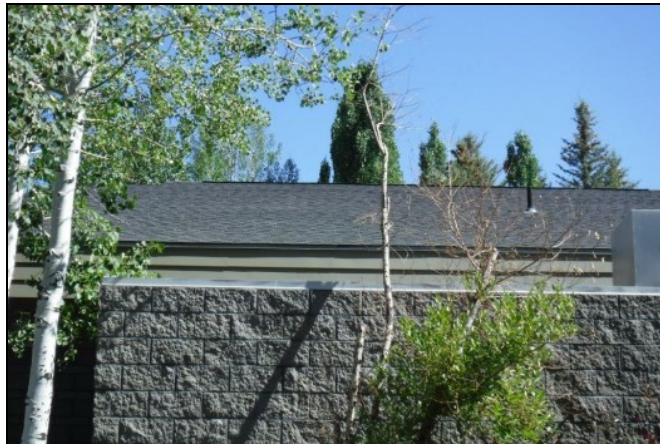
**Comp #: 285 Clubhouse Steep Slope Roof -Replace**

Comments: Composition shingle steep slope roof at Village pool clubhouse is reportedly original to ~ 1999 construction. No problems were reported at the time of our site visit. Our view of the roof was limited to ground level viewing, however no obvious damage, missing shingles, etc. observed. A reserve study conducts only a limited visual review, and many of the critical waterproofing and ventilation items of the roof are not readily viewable. For a full evaluation have a professional roof consultant/contractor perform a thorough up-close survey of your entire roof system, including attic inspection (if any).

As routine maintenance, many manufacturers recommend inspections at least twice annually (once in the fall before the rainy season, and again in the spring), and after large storm events. Promptly replace any damaged/missing sections, or any other repair needed to ensure waterproof integrity of the roof. Keep the roof surface, gutters, and downspouts clear and free of moss or debris.

At the time of re-roofing, we recommend that you hire a professional consultant to evaluate the existing roof, specify the new roof materials/design, and provide installation oversight. We recommend that all Associations hire qualified consultants whenever they are considering having work performed on any building envelope (waterproofing) components including; roof, walls, windows, decks, exterior painting, and caulking/sealant.

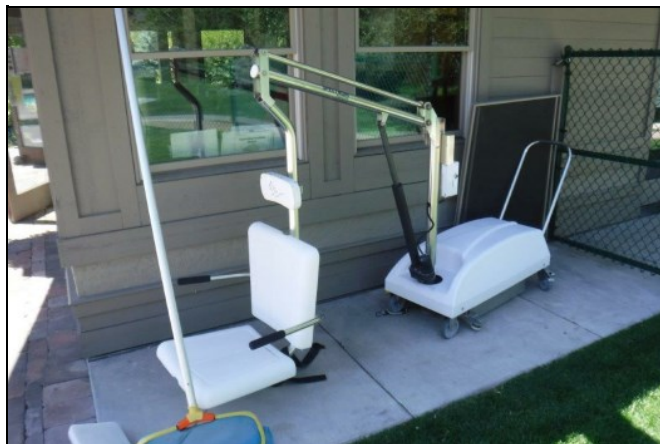
**Comp #: 422 ADA Lift - Replace**

Location: Within Harker pool area  
Funded?: No. Cost projected to be too small to qualify for reserve funding  
History: Replaced 2015 \$6,850.43  
Comments: No problems reported of ADA lift at the time of our site visit. Association records indicated that lift was replaced in 2015 at a cost of \$6,850.43.

Cost to replace lift is projected to be too small to qualify for reserve funding, therefore best handled as operating expense on an as-needed basis.

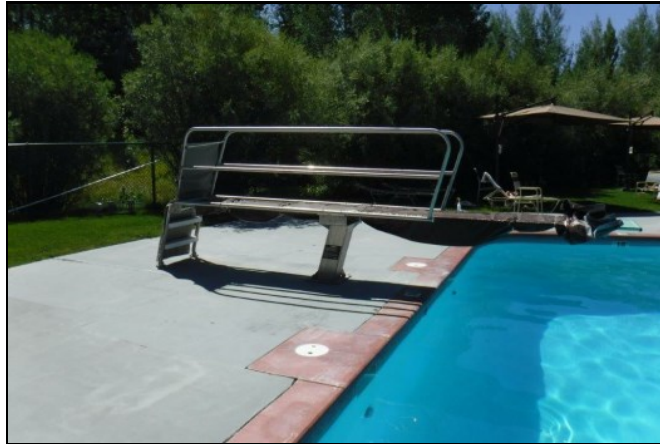
**Comp #: 425 Diving Board - Replace**

Comments: Association records indicated that diving board was replaced in 2019 at a cost of \$22,317.89.

This component factors periodic cycles of replacement, with the next cycle timed to coincide with major pool renovations for cost efficiencies.

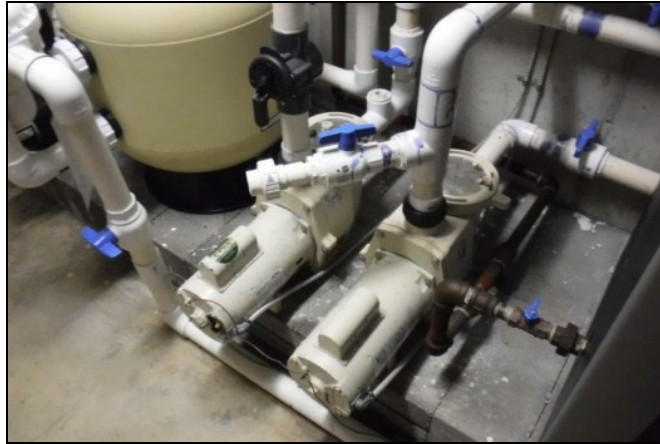
**Comp #: 430 Spa/Wading Pumps/Filters - Replace**

Location: Within pool equipment room in basement of Harker Center  
Funded?: No. Cost projected to be too small to qualify for reserve funding  
History: Filter repair 2017 \$1,077  
Comments: Spa and wading pool equipment included three smaller pumps and two sand filters. No problems reported at the time of our site visit.

Equipment appears to vary in age. Cost to replace this equipment individually is projected to be too small to qualify for reserve funding, therefore best handled as operating expense. Often, pumps can be rebuilt rather than completely replaced.

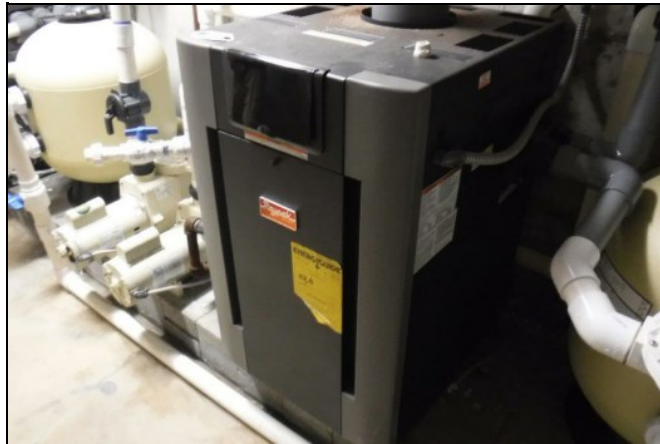
**Comp #: 432 Spa/Wading Heaters - Replace**

Provide regular service, and maintain as recommended by the manufacturer.

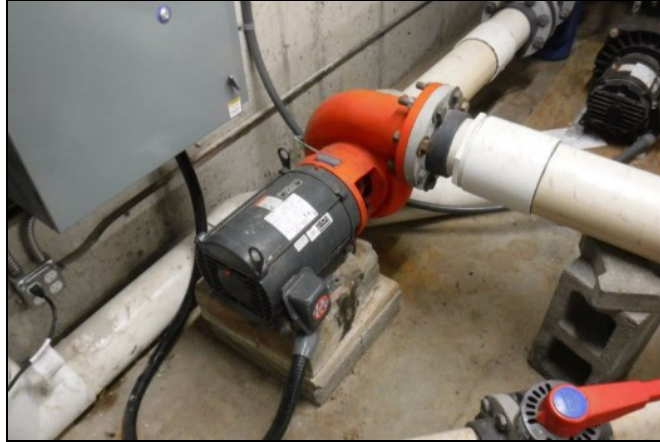
**Comp #: 435 Pool Pumps - Replace**

Comments: No problems reported of pool pumps at the time of our site visit. Association records indicate a history of repairs in 2017 and 2020.

This component factors periodic replacement of pumps, timed to coincide with major pool remodel for cost efficiencies, Often times, pump can be rebuilt rather than completely replaced.

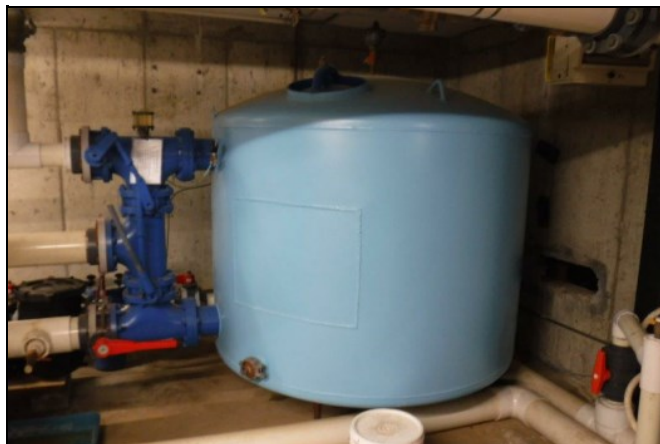
**Comp #: 437 Pool Filters - Replace**

Comments: No problems reported of pool filters at the time of our site visit. Pool featured two large filters, association records indicate replacement in 2011 \$27,040.01.

Plan to replace at roughly the time frame below. Cost is as provided by vendor and includes installation.

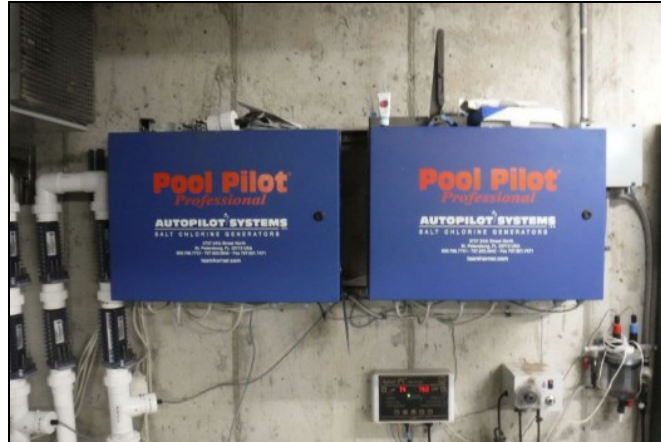
**Comp #: 438 Pool Chem Control - Replace**

Association vendor recommends that at time of system replacement the association moves to a chlorine system due to the corrosive nature of salt on the association's equipment. Wading pool and spa reportedly do not have chemical control systems.

Inspect regularly, and repair components, as needed, using operating funds for full design life.

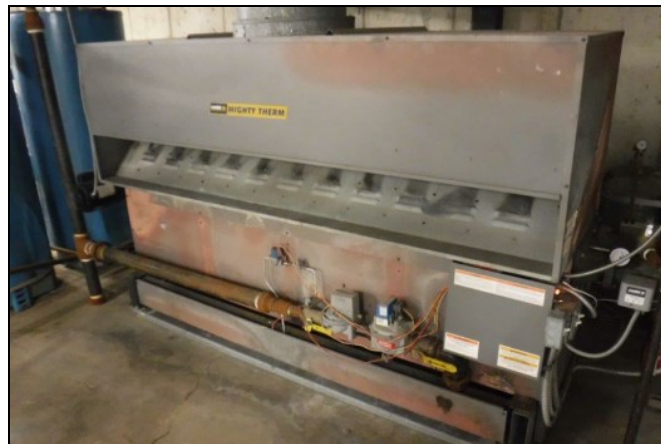
**Comp #: 439 Pool Heater - Replace**

Provide regular service, and maintain as recommended by the manufacturer.

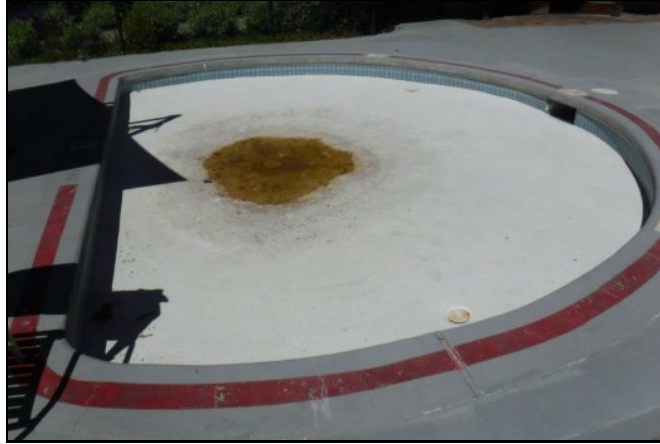
Comments: Components # 400-439 represent future replacement cycles for individual components, however this component factors additional costs associated with periodic major renovations to pool area. Cost allowances here are based on Village pool renovation costs as we anticipate scope of large scale renovation to be similar at roughly the 40 year mark.

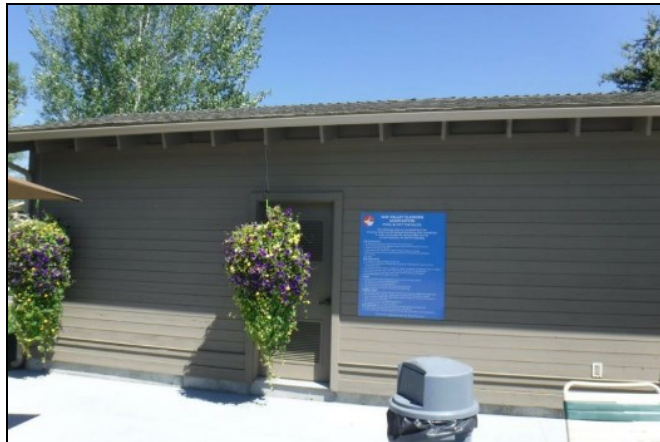
This component factors periodic replacement of composition building roof. While this cost falls below the reserve funding threshold, we have included funding as requested by client.

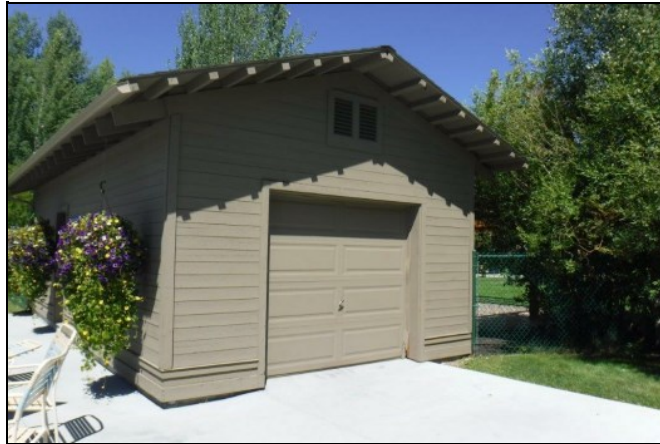
This component factors periodic replacement of siding. Cost to paint is projected to be too small to qualify for reserve funding, therefore best handled as operating expense.

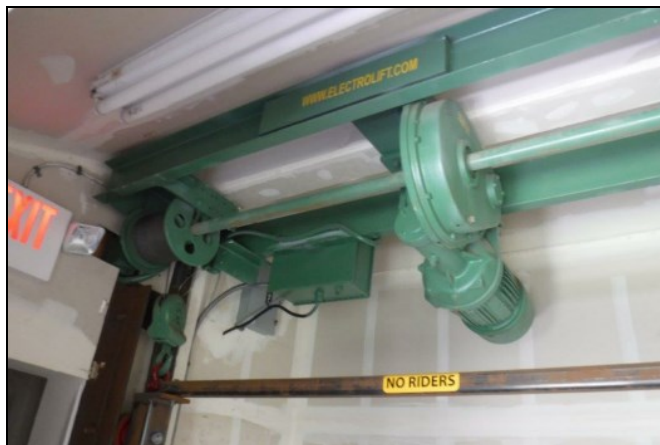
**Comp #: 455 Electric Hoist - Repair/Replace**

This hoist is expected to receive relatively little use and there is no basis to expect complete replacement of entire unit. Motor may require repair or rebuild, however frequency and extent is difficult to predict. No reserve funding included at this time due to unpredictable nature of this component. Handle repairs through the operating budget.

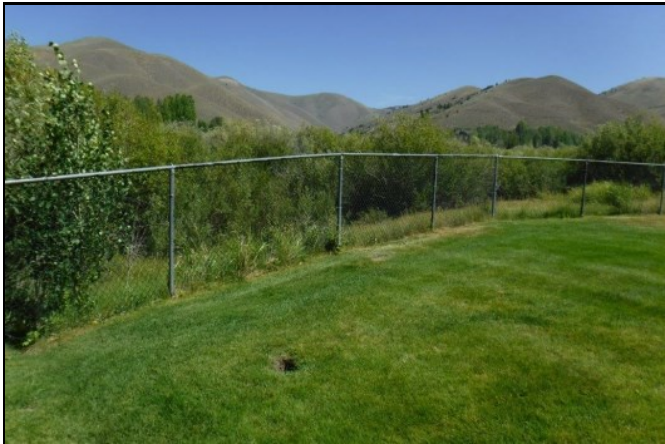
**Comp #: 500 Chain Link Fence - Replace**

Comments: Fencing at park appeared to be older chain link with galvanized rails. Our source reported plans to replace the chain link infill in the near future.

Chain link fencing is generally a low maintenance item. Inspect periodically, and repair as needed. If corrosion is observed, apply rust inhibitor to prevent corrosion from decreasing the useful life.

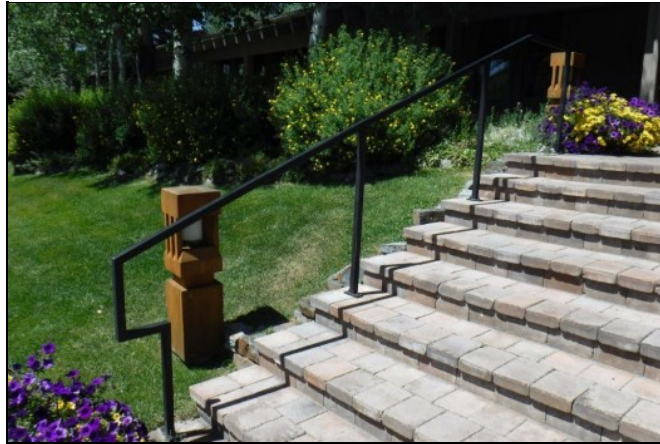
**Comp #: 712 Metal Site Rail - Replace**

With regular cycles of paint (best handled as operating expense as low in cost to paint this small quantity of railing) railing should have an extended useful life, and if replacement is required we anticipate the cost to be too small to qualify for reserve funding as this is a relatively small quantity. Therefore, inspect, repair and replace as needed utilizing general maintenance operating funds.

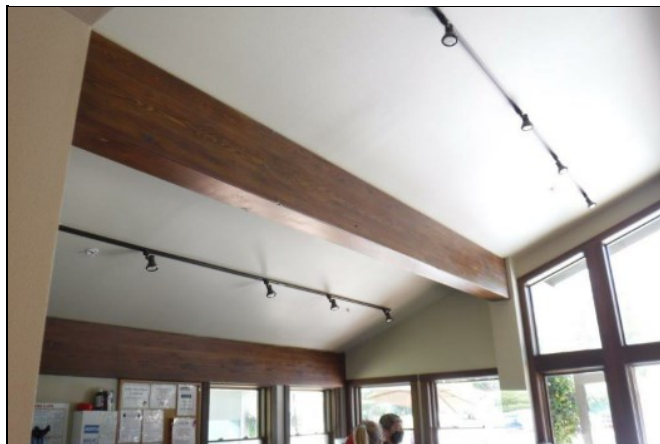
Comments: Painted surfaces were noted to be in generally clean, intact condition.

Regular cycles of professional painting are recommended to maintain appearance; best timed prior to any flooring replacement.

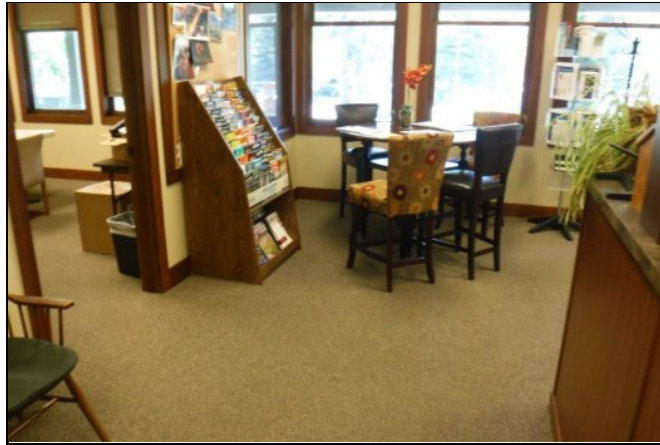
**Comp #: 735 Carpet - Replace**

Actual replacement cost can vary greatly based on carpet and pad material chosen. A wide variety of type and quality is available; a funding allowance is factored below for financial planning purposes.

As part of an ongoing maintenance program, vacuum regularly, and professionally clean as needed. Replacement best timed just after repainting for cost efficiency, and to maintain a quality appearance.

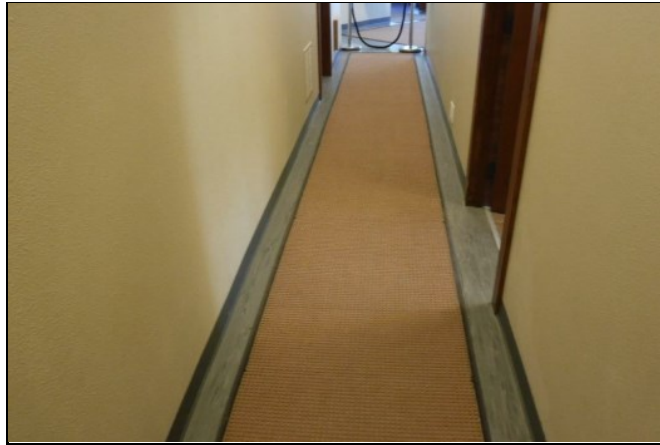
**Comp #: 737 Laminate Flooring - Replace**

Actual replacement cost can vary greatly based on quality of material chosen. A wide variety of type and quality is available; a mid-range funding allowance is factored below for financial planning purposes.

As part of an ongoing maintenance program clean regularly. Replacement best timed just after repainting for cost efficiency, and to maintain a quality appearance.

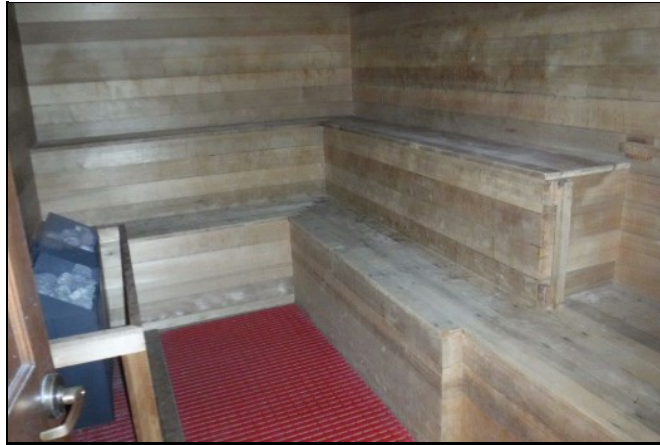
**Comp #: 739 Sauna - Repair/Replace**

Comments: Generally, the cedar wood interior of the sauna appeared to be in intact condition.

Repair as needed using general maintenance funds. Clean saunas periodically as needed. Light sanding can refresh the appearance of cedar interior. Inspect the heater regularly and test for performance, repair promptly to ensure safety. Heater element replacement cost should be less than \$1,000. If larger-scale repair becomes known, funding can be added to a future reserve study.

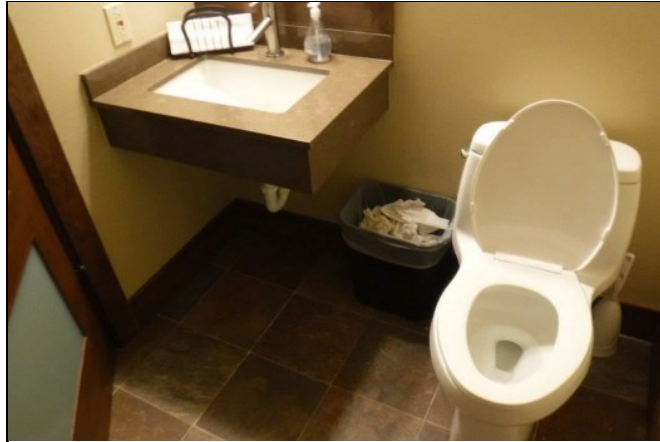
Clean and maintain as needed to extend useful life. Simple, durable materials typically have an extended useful life, however, many communities choose to refurbish restrooms periodically for aesthetic updating, and/or function. Doing so may include flooring, cabinets (reface or replace), sinks and other plumbing fixtures, counter tops, lighting, ventilation, etc.

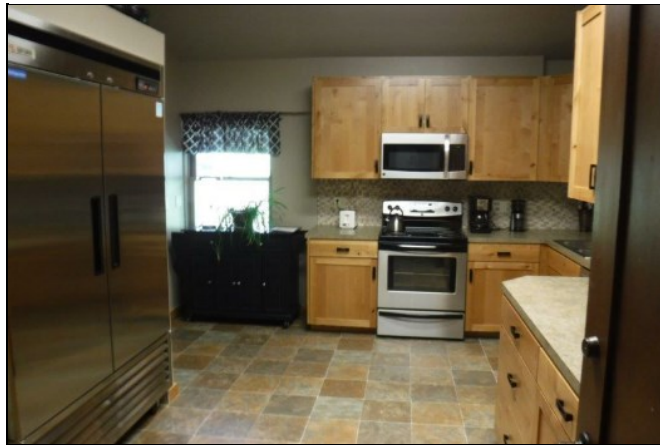
Comments: Association records indicate that Harker Center kitchen was remodeled in 2015 at a cost of \$20,912.16. Kitchen was reportedly not done as part of the 2008/2009 Harker Center remodel. Kitchen appeared generally clean and modern, with no major damage or deterioration observed. Appliances included chest freezer, Saturn fridge, dishwasher, stove and microwave. Finishings included laminate counters and wood cabinets.

Clean and maintain as needed to extend useful life. Simple, durable materials typically have an extended useful life, however, many communities choose to refurbish the kitchen periodically for aesthetic updating, and/or function. Doing so may include appliances, cabinets (reface or replace), sinks, counter tops, lighting, ventilation, etc.

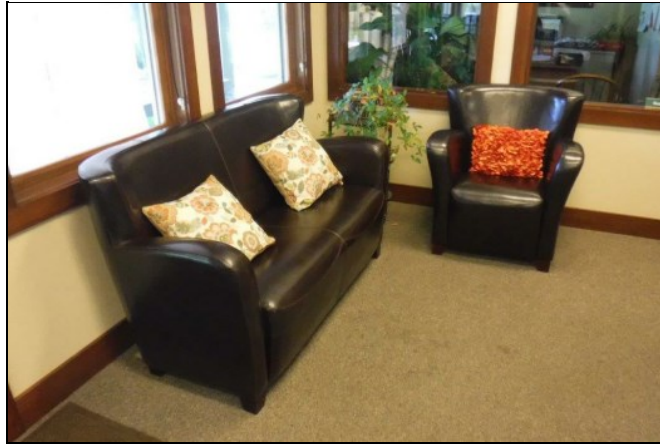
Comments: Association records show large scale remodel occurred at Harker Center around 2008/2009. Costs also appeared to include Harker tennis clubhouse and Village pool clubhouse. Furniture appeared to vary in age and condition.

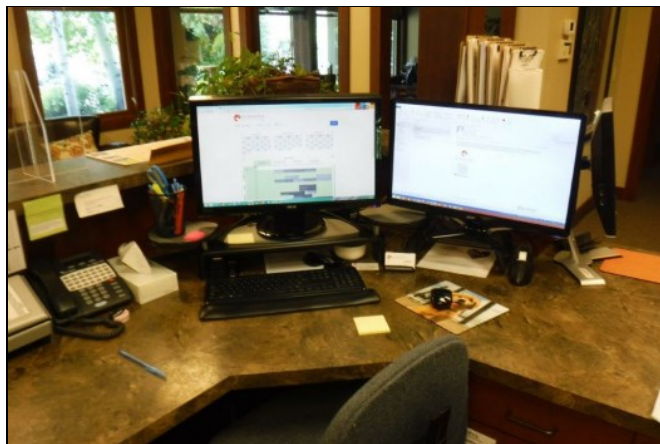
**Comp #: 762 Computer Stations - Replace**

Comments: Association features 10 computer stations within Village pool (2), Village courts (1), Harker courts (1), Harker pool (1) and Harker Center offices (5). Association has a varied history of primarily individual replacement as noted above. Work stations also feature miscellaneous smaller equipment.

Due to varying ages of equipment there is no predictable basis to expect wide scale replacement affecting reserves, therefore replace equipment as needed utilizing annual operating funds.

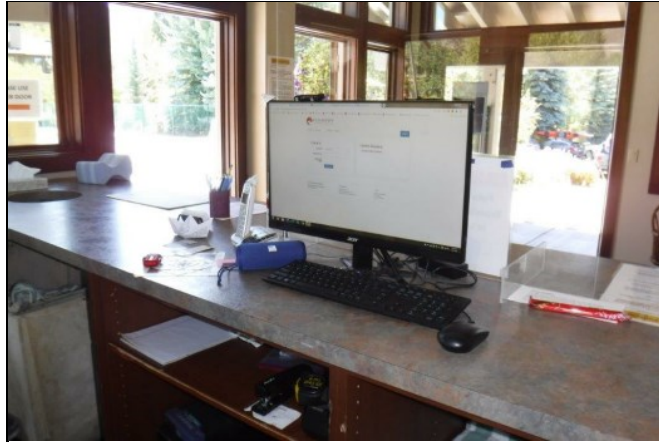
We have included funding here as requested by client for periodic larger software upgrades. Cost can vary widely based on scope, therefore we recommend researching this project well in advance and updating any future reserve studies as necessary.

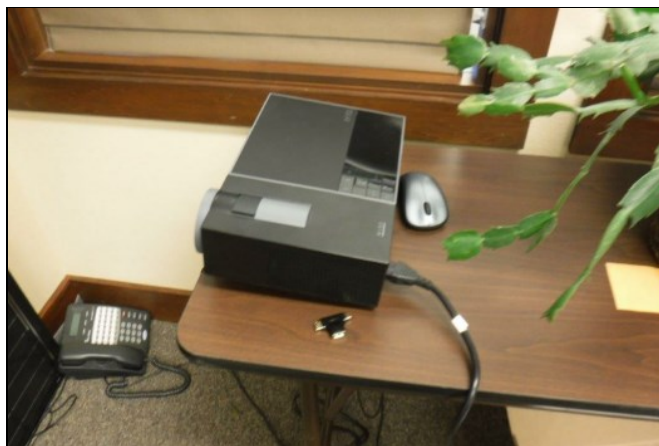
**Comp #: 764 Audio Visual Equipment - Replace**

There is no basis to expect widescale replacement at a cost range affecting reserves, and individually equipment is projected to be too small in cost to qualify for reserve funding. Best replaced as needed utilizing general maintenance operating funds.

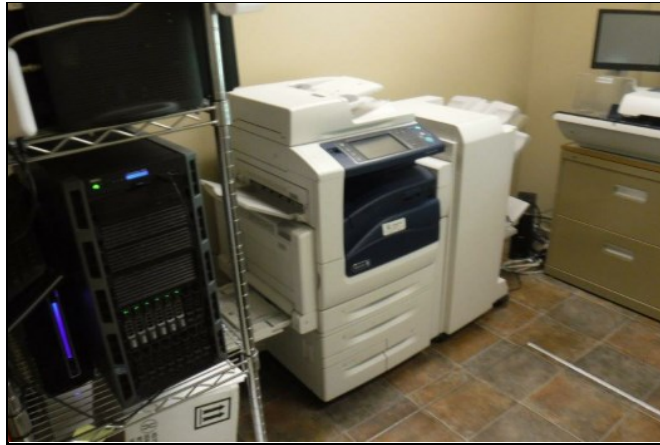
**Comp #: 765 Copy Machines - Replace**

Comments: Two copy machines were on site at the time of our site visit, a Sharp black and white copier and a Xerox color copier. Our source reported that equipment is owned by the association and the black and white copier would not be replaced when it fails. Therefore, funding herein is for color copier only. Association records indicate that color copier was last replaced in 2014 at a cost of \$12,716.82.
